# The Oamaru Steam and Rail Digest

September 2018

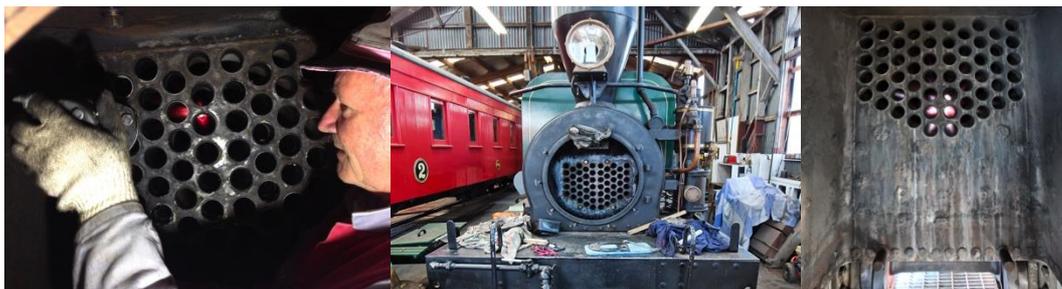
A notable achievement for the month was the installation of B10's boiler tubes. 48 of these metal pipes sit between thick steel 'tubeplates' at the front and rear of the boiler. The tubeplates each have 48 slightly-oversize holes so that the tubes can be inserted freely, and then their ends must be expanded in diameter against the holes to provide a water and steam-tight seal.

A hydraulic tube expander was hired from Christchurch, and over a period of three days, each tube was positioned, clamped and rolled into place at each end of the boiler – 96 expansions in total.

Following this tube rolling, B10's boiler was filled with water to test the work. A small number of tubes needed to be re-rolled to eliminate a few leaks. The water was then manually pumped up in stages to just above the loco's normal maximum operating pressure and the tube work was declared sound. Unfortunately, a couple of unexpected leaks showed up in various control valves and at the regulator. These issues will be attended to next.

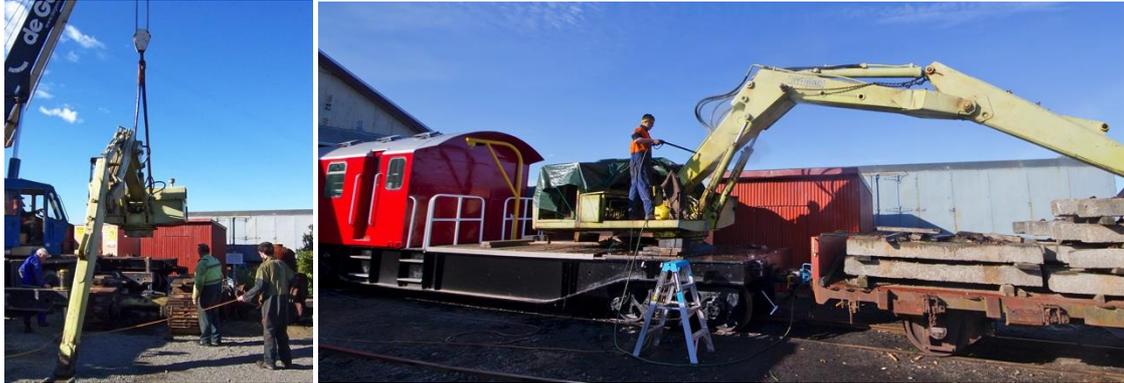
This continues to take shape with the top of the Hymac excavator now securely installed in place and undergoing restoration. In addition to a general overhaul of its motor and hydraulics, a replacement slew motor will be installed to reinstate the digger's ability to swivel around. The cab has been removed for refurbishment and controls are being adjusted to match modern practice. Parts have been designed and cut out of thick steel for a new 'claw' attachment that will be used to pick up and install sleepers.

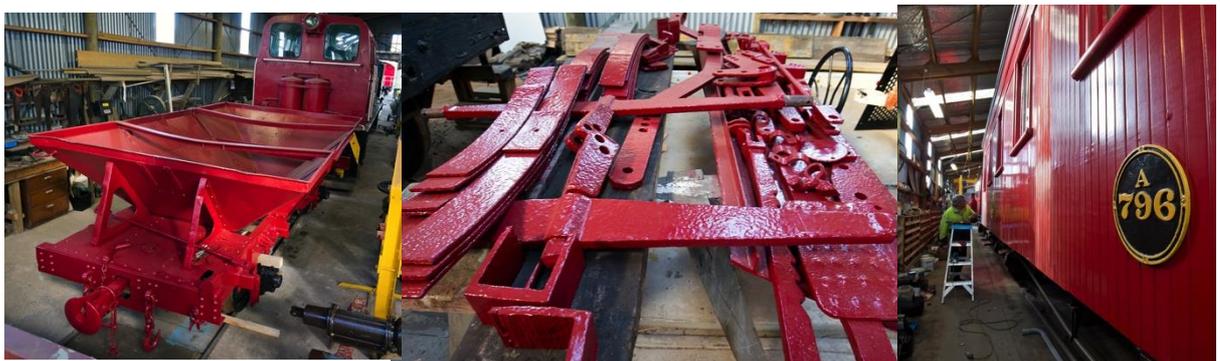
Work continues with the ballast wagon. Its body has been painted, flipped back upright, and placed onto roller bearing wheelsets. The jigsaw of brake and spring components has been painstakingly cleaned up and painted, and these are being reassembled.
